1. REPORT DATE (DD-MM-YYYY) September 2014		2. REPORT TYPE Technical Paper		3. DATES COVERED (From - To) September 2014- October 2014	
4. TITLE AND SUBTITLE Quantitative Diagnostics of Multilayered Composite Structures with Ultrasonic Guided Waves				5a. CONTRACT NUMBER FA9300-11-C-3008	
				5b. GRANT NUMBER	
				5c. PROGRAM ELEMENT NUMBER

Quantitative Diagnostics of Multilayered Composite Structures with Ultrasonic Guided Waves

Gheorghe Bunget^{1, a)}, Fritz Friedersdorf^{1, b)}, and Jeong K. Na^{2, c)}

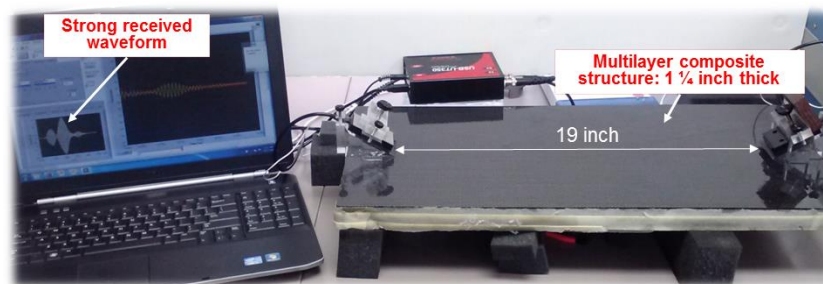
FIGURE 6. A portable ultrasonic scanning system was designed and tested successfully on multilayered structures including the ones with carbon fiber skin.

Two different experimental setups were prepared: a bulky high-power amplifier based system and a compact portable pulser/receiver based system. For the first system, a programmable function generator was used to generate sinusoidal signals that were amplified using a 150-watt RF power amplifier before the signals sent to the transmitting transducer. Then, full traces of the received signals were filtered with a low-pass filter having a cutoff frequency of 0.5 MHz followed by waveform averaging on a digital oscilloscope before being processed on a computer. On the contrary, the second system shown in Figure 6 used a compact portable high-voltage pulser/receiver unit and a laptop computer for DAQ and data analysis. All test specimens were scanned by sliding the transmitter and receiver (pitch-catch) across the surface. The propagation distance was 500 mm for the plates and 180 mm for the half-tubes. In the case of half-tubes, the transducers were moved only along the circumferential direction.

The portable ultrasonic system was used to track the scan position, collect ultrasonic data, analyze the results, and provide B-scan images in real time. The guided waves were launched from the outer surfaces of the test specimens by using acrylic coupling shoes. In this way, the guided wave energy was launched through the tip section of the shoe and subsequently propagating along the surface of the test specimen. Time domain signal processing was applied to analyze the received waveforms.
